Project No.
5698.002.021

Subject: Paradise Valley Maintenance and Monitoring District
Fairfield, California

MONITORING REPORT – FALL 2021

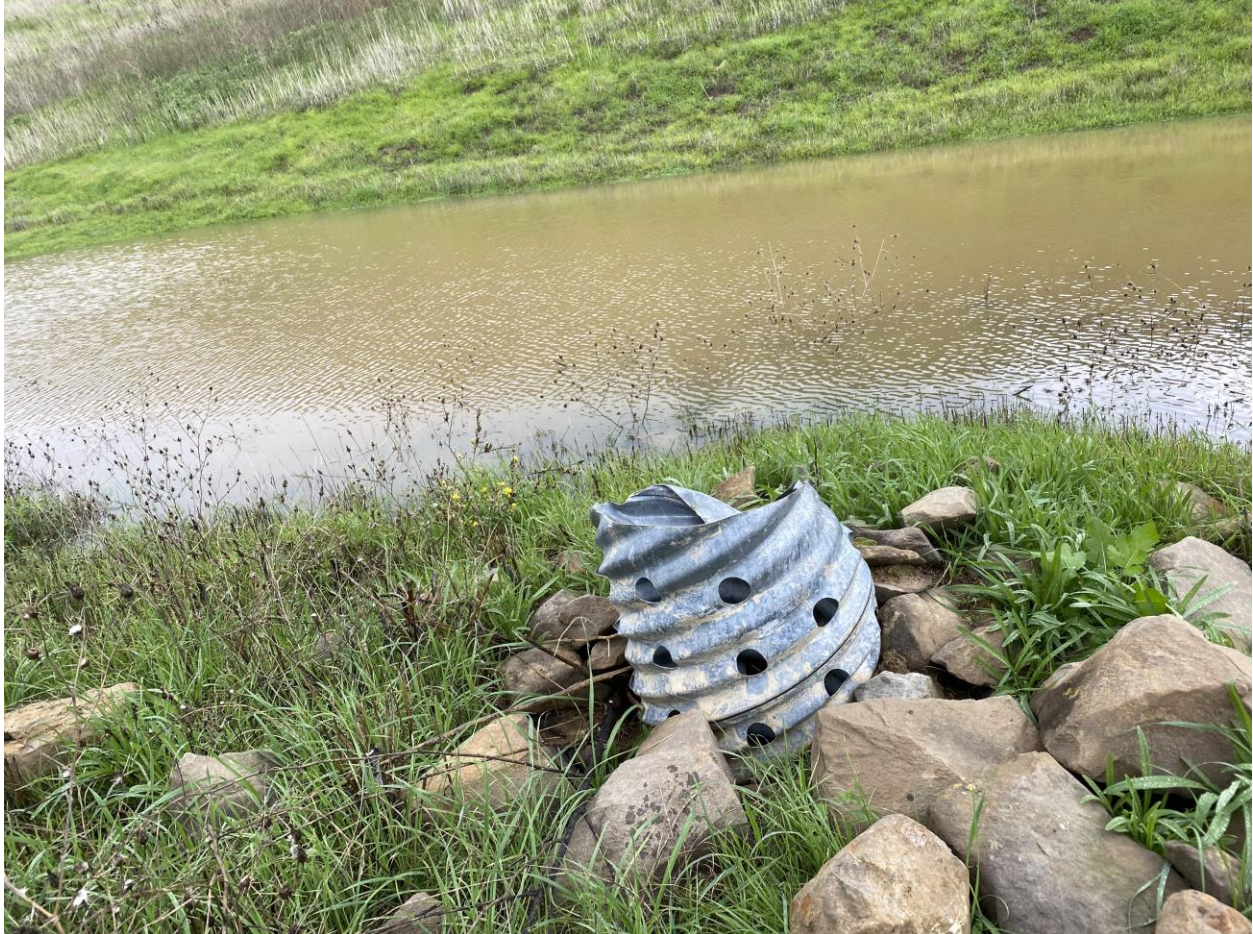
PHOTOGRAPH 1: Site Condition A

Damaged outlet drainage pipe with missing grate in Sedimentation Basin “A”

- The outlet pipe from Sedimentation Basin “A” should be repaired so that a grate can be installed to prevent large debris from entering and potentially clogging the outlet pipe (Figure 1, Site Condition A, Photograph 1).

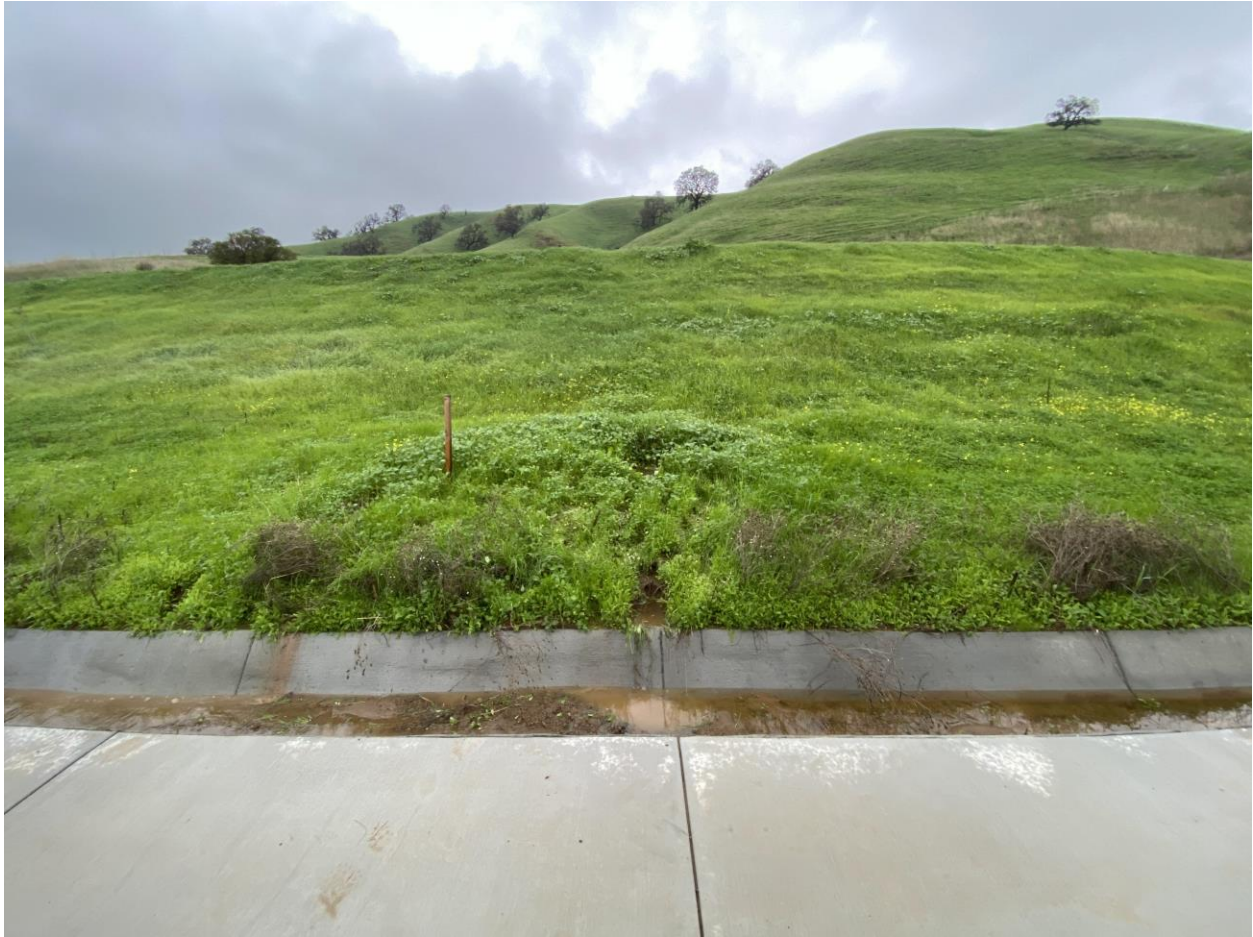
PHOTOGRAPH 2: Site Condition B

Buried pipe outlet apron from Sedimentation Basin "I"

- The outlet pipe and dissipator from Sedimentation Basin “I” is partially buried and should be exposed and reconstructed to allow for proper drainage from the sedimentation basin (Figure 1, Site Condition B, Photograph 2).

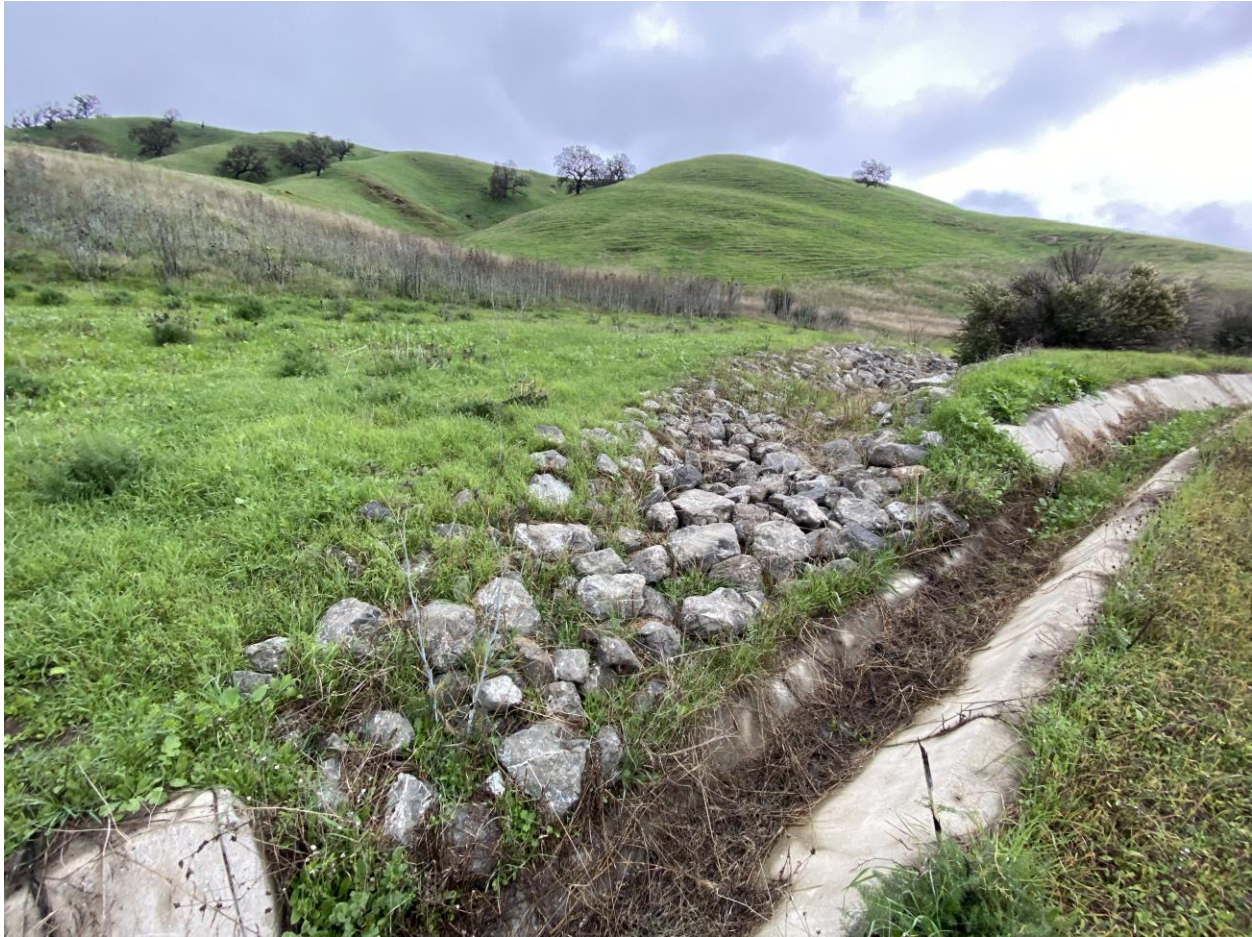
PHOTOGRAPH 3: Site Condition C

Vegetation growth within riprap outfall apron for Sedimentation Basin "1"

- A riprap-lined overflow channel is located at the terminus of the western swale exiting Sedimentation Basin “I” (Figure 1, Site Condition C, Photograph 3). Vegetation, perennial and annual, should be removed to maintain its capacity.

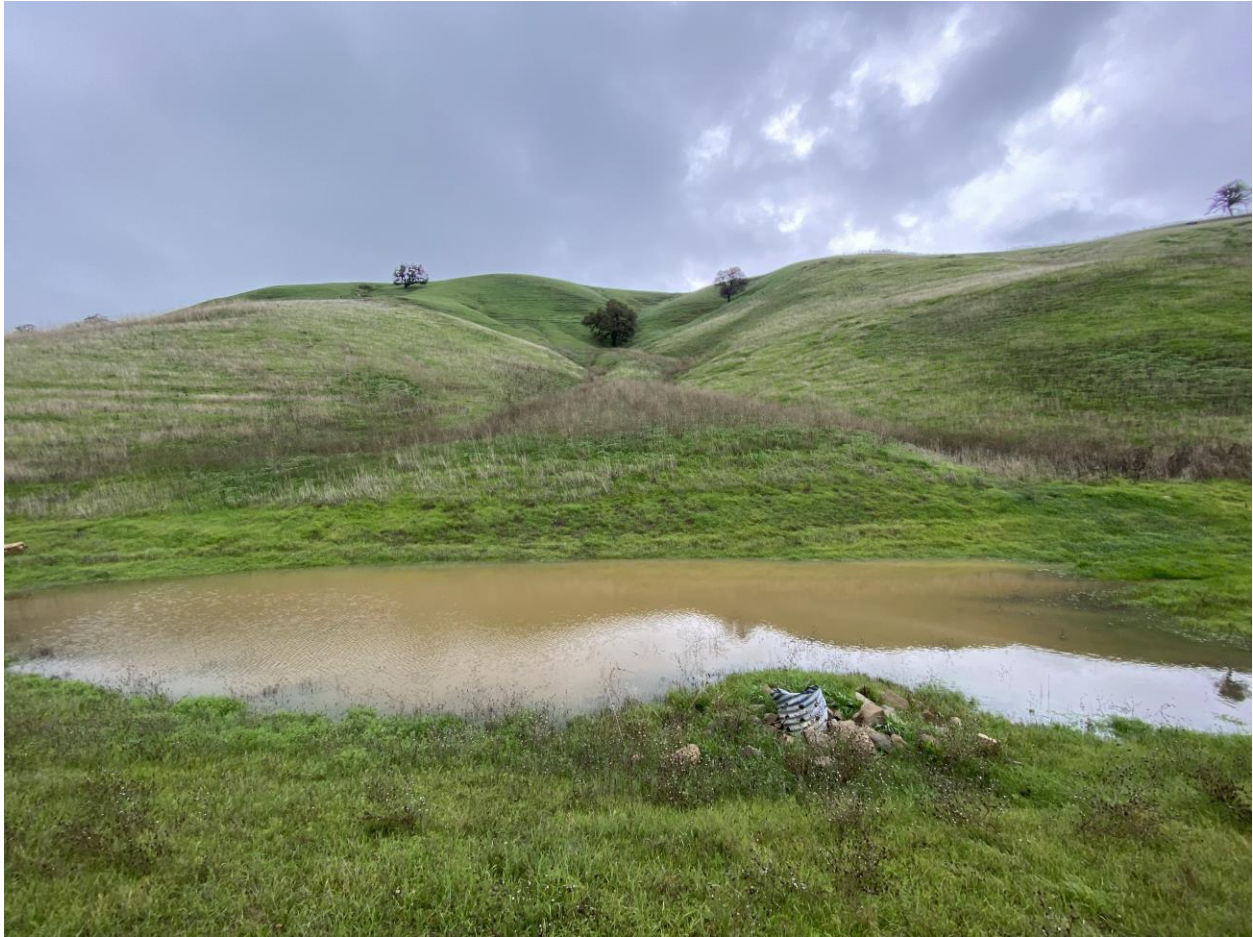
PHOTOGRAPH 4: Site Condition D

Accumulated sediment partially covering riprap-lined aprons at terminus of swales upslope of Sedimentation Basin "A".

- Two riprap-lined aprons are located at the terminus of swales entering at the upslope edge of Sedimentation Basin “A”. A significant amount of sediment has accumulated at the terminus of the swales and has partially covered the riprap-lined aprons (Figure 1, Site Condition D, Photograph 4). Removal of accumulated sediment should be undertaken to reduce surface flows velocities for water entering Sedimentation Basin “A”.

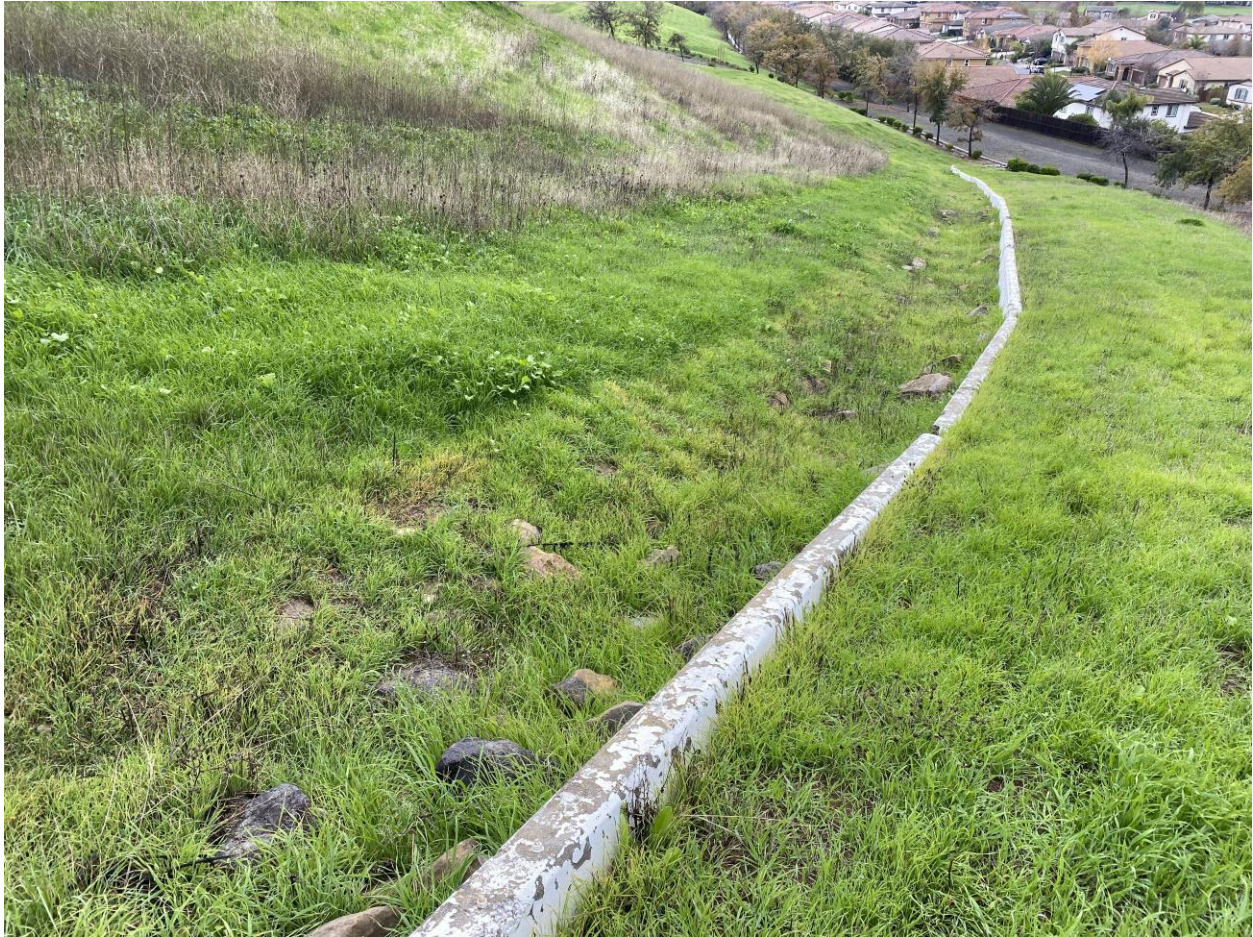
PHOTOGRAPH 5: Site Condition E

Deflection wall east of Sedimentation Basin "A" filled with soil and vegetation

Three deflection walls are located within the District (Figure 1). Two of the three deflection walls do not appear to have accumulated significant volume of sediment against the deflection walls and riprap outfall structures. However, the deflection wall east of Sedimentation Basin “A” has accumulated significant soil and vegetation against the deflection walls and within the riprap outfall structures (Figure 1, Site Condition E, Photograph 5). Vegetation should be removed from the riprap structures along the deflection walls to provide adequate capacity of the deflection walls.

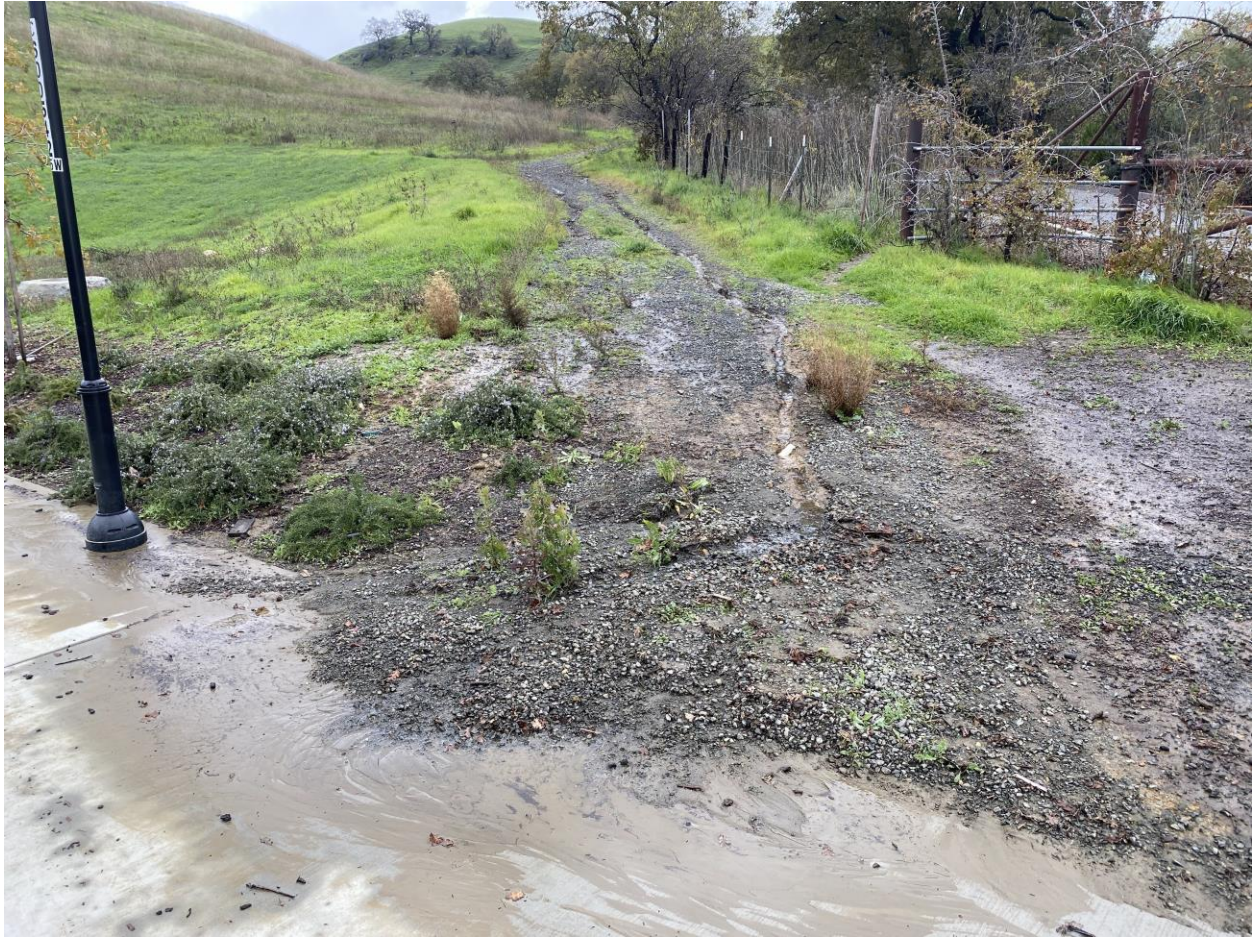
PHOTOGRAPH 6: Site Condition F

Erosion gully within maintenance road north of Area "L"

In general, most of the gravel-surfaced maintenance roads were in good condition with the exception of some areas with moderate vegetation. However, the maintenance road to the east of the concrete-lined drainage ditches near Area “L” has significant erosion gullies from overflow of the concrete-lined drainage ditches (Figure 1, Site Condition F, Photograph 6). The maintenance road should be lightly regraded to restore the gravel-surfaced roadway to its original design condition.

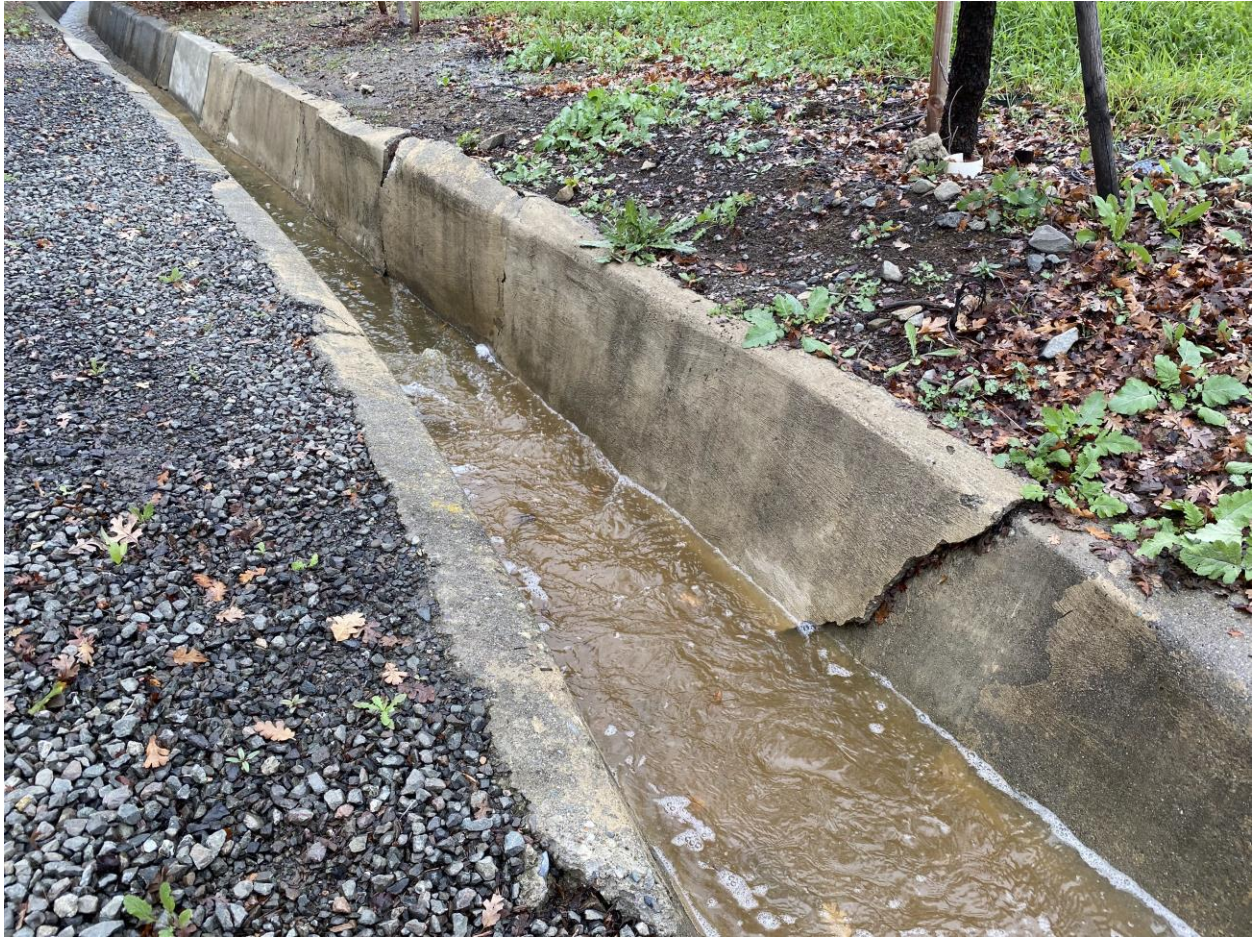
PHOTOGRAPH 7: Site Condition G

Damaged section of concrete-lined drainage ditch

It appears that cracks within most of the ditches have been sealed at least once previously but are in need of sealing or resealing. It should be expected that minor cracking will occur in the ditches and sealing or resealing of the cracks should be anticipated every 2 to 3 years. Less cracking was observed in the “V”-shaped concrete-lined ditches as compared to the flat-bottomed concrete-lined ditch adjacent to Couples Circle. Mechanical damage was observed in several areas from equipment used to access the open space (Figure 1, Site Condition G, Photograph 7). In damaged areas, soil should be removed, and the concrete-lined drainage ditch should be repaired or replaced.

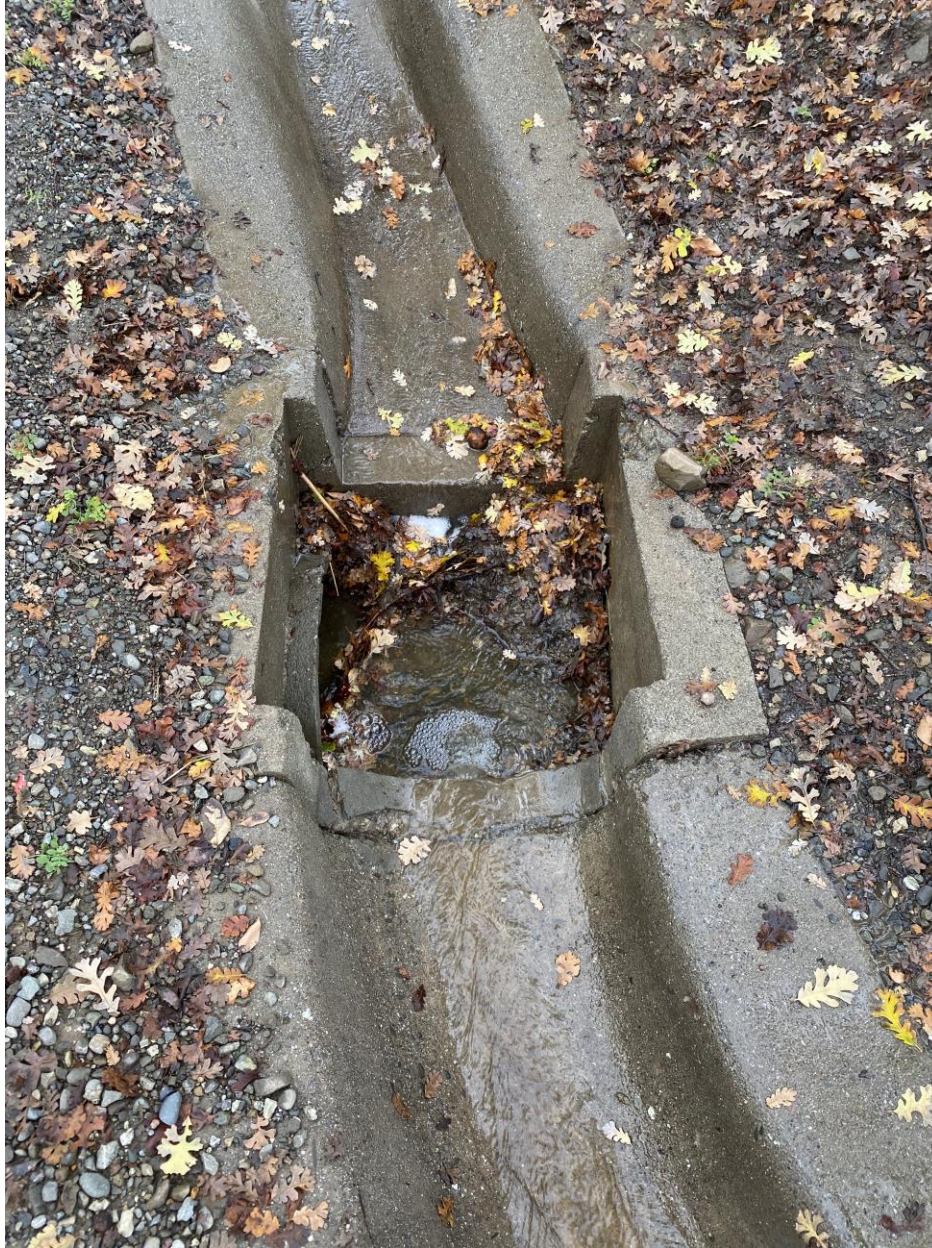
PHOTOGRAPH 8: Site Condition H

Storm drain inlet with missing grate

In general, the storm drain inlets located within the open-space parcels were relatively free of vegetation and debris. The storm drain inlets located in the concrete-lined drainage ditches north of 1384 and 1392 Couples Circle have missing grates (Figure 1, Site Condition H, Photograph 8). The grates should be replaced to prevent significant amounts of debris from entering the storm drain system and help eliminate a trip hazard.

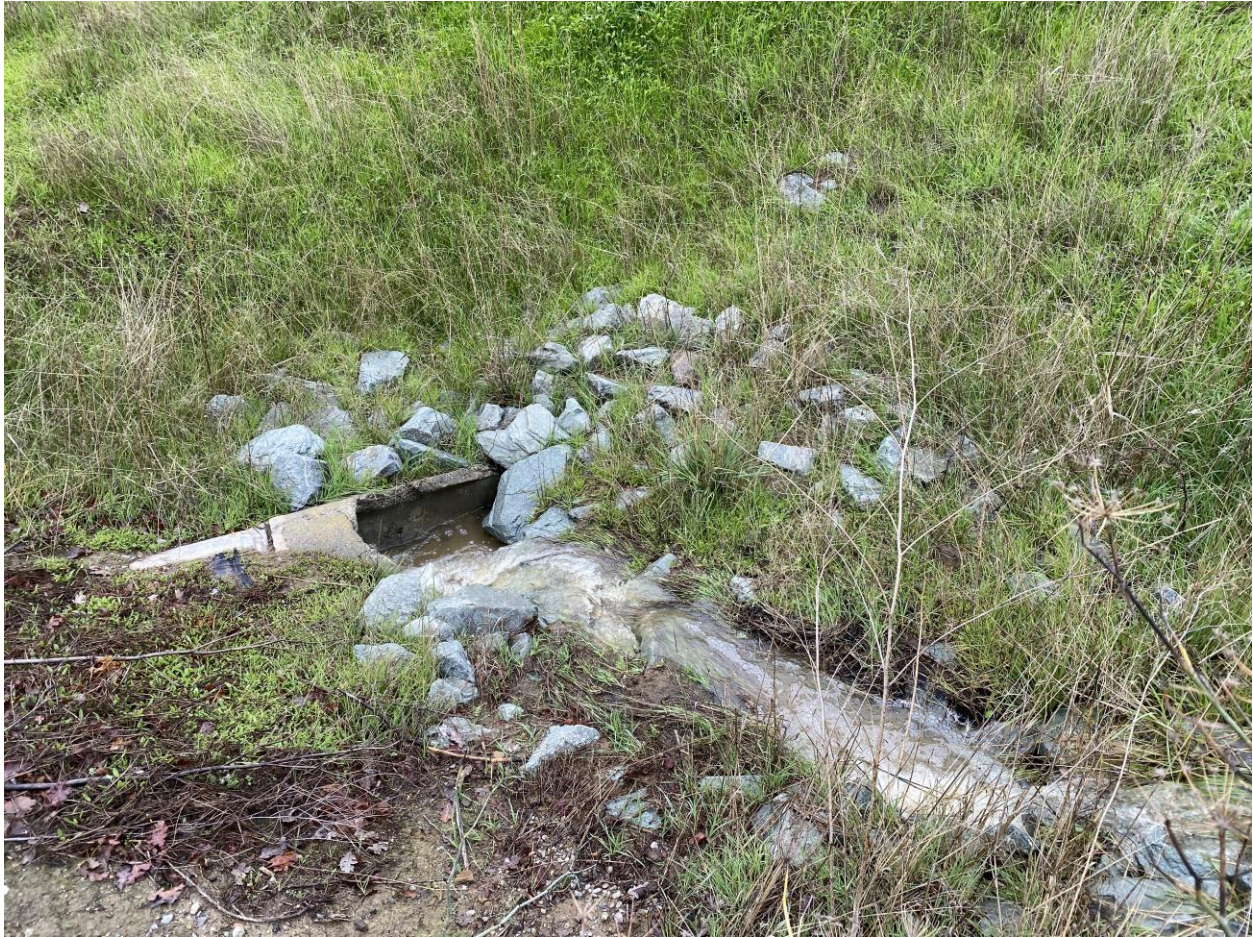
PHOTOGRAPH 9: Site Condition I

Damaged storm drain pipe along paved access road for Solano Irrigation District Water Reservoir

There is an exposed, damaged storm drain inlet pipe next to the access road intersection near the Solano Irrigation Water Reservoir (Figure 1, Site Condition I, Photograph 9). If this storm drain pipe is responsibility of the PVMMD, it should be repaired to maintain integrity of the storm drain pipe in the long term.

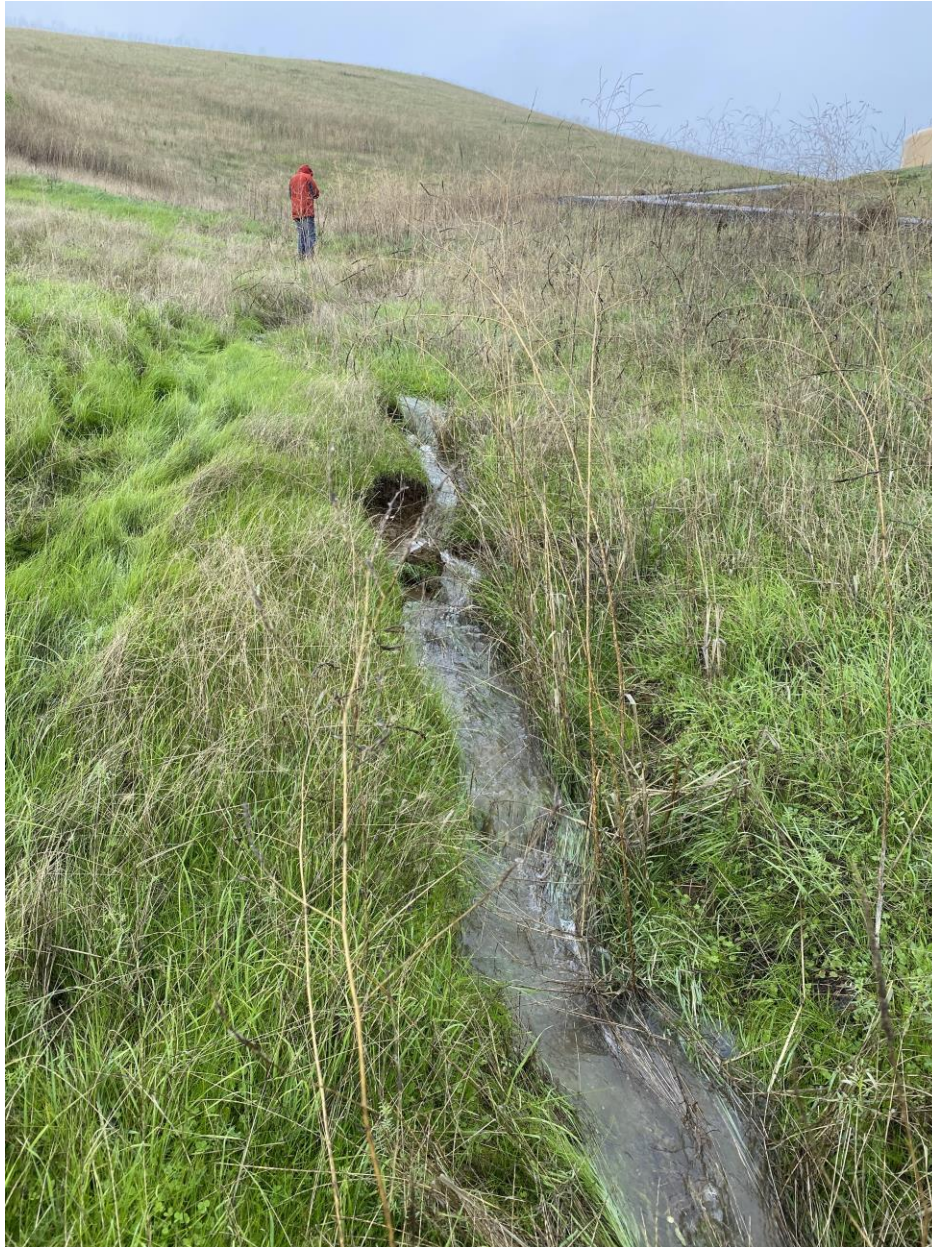
PHOTOGRAPH 10: Site Condition K

Erosion gully south of access road to Solano Irrigation District Water Reservoir

An erosion gully is located approximately 30 feet south of the access road to the Solano Irrigation Water District Reservoir (Figure 1, Site Condition K, Photograph 10). The gully is up to approximately 125 feet in length, 3 to 4 feet in width, and up to about 2 to 3 feet in depth. We recommend this erosion gully be backfilled with riprap as described in Reference 5.

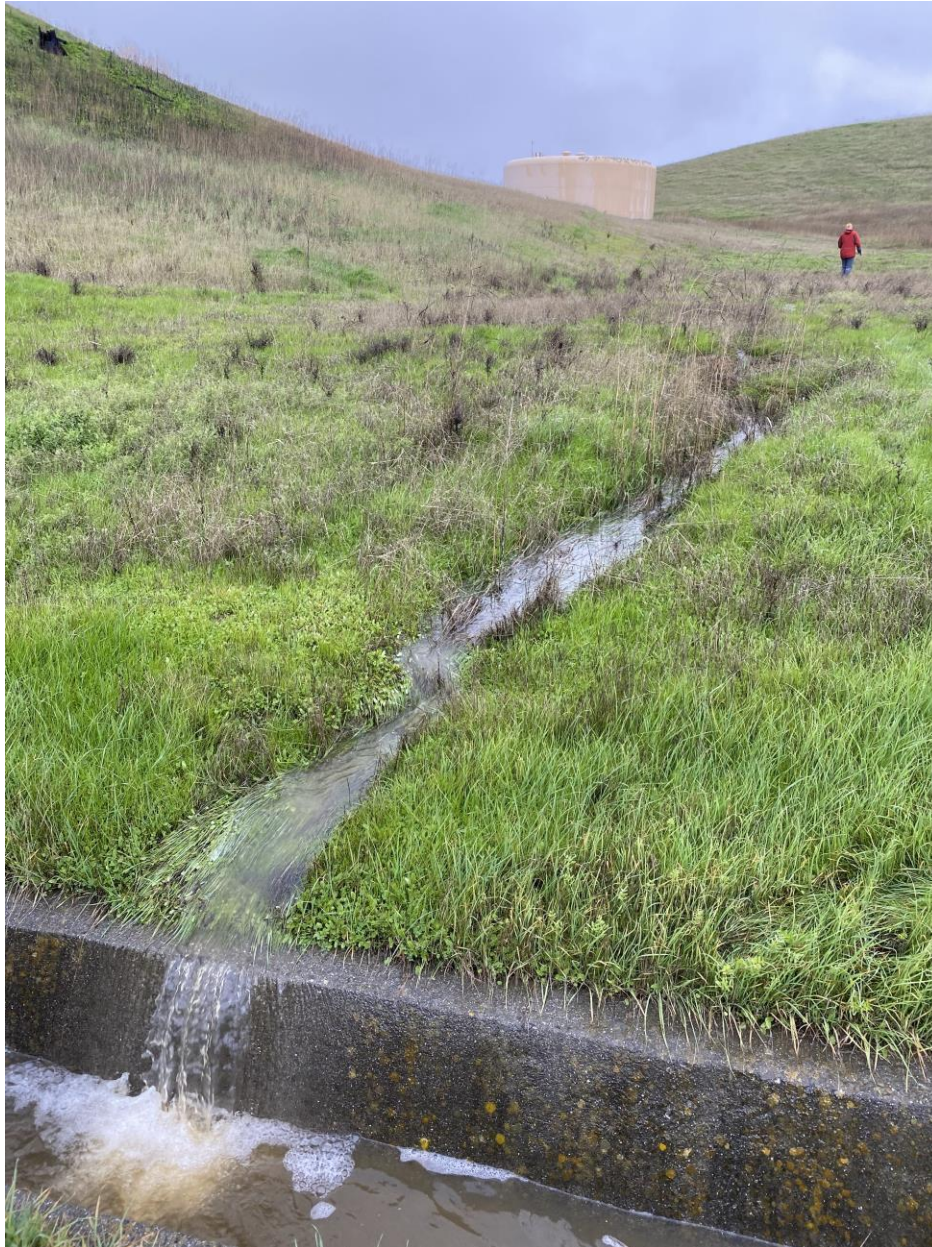
PHOTOGRAPH 11: Site Condition L

Additionally, there is an erosion gully near the offsite underground water storage facility that drains into the offsite concrete-lined drainage ditch (Figure 1, Site Condition L, Photograph 11). At the time of the site visit, these erosion gullies do not threaten any improvements within the open space, but should be monitored during future scheduled monitoring events.

Erosion gully flow discharging into offsite concrete-lined drainage ditch north of Solano Irrigation District Water Reservoir

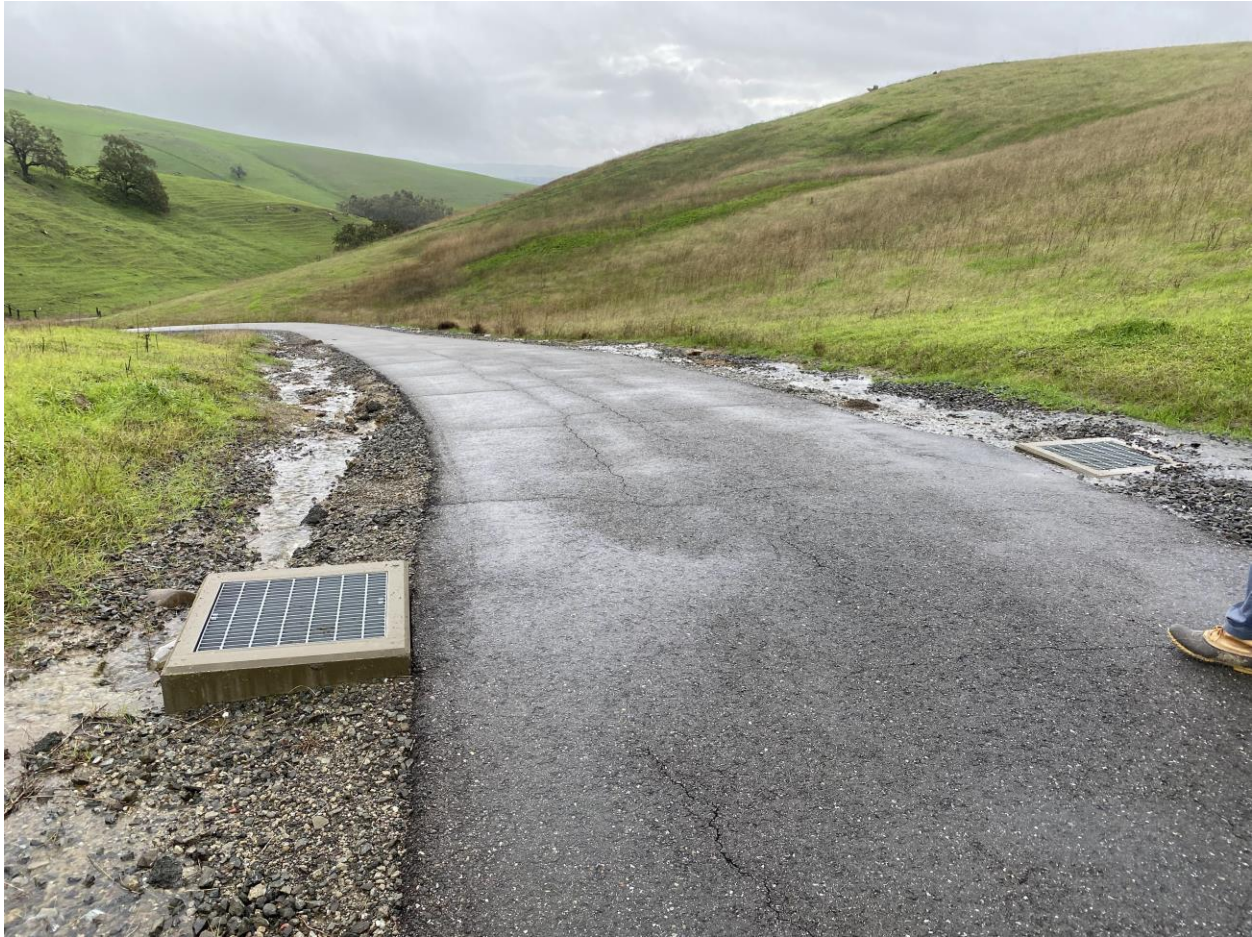
PHOTOGRAPH 12: Site Condition M

Erosion gullies along paved access road to Solano Irrigation District Water Reservoir

There are two riprap swales with storm drain inlets along the Solano Irrigation District Water Reservoir paved access road. Significant erosion gullies are present within the riprap swales due to the differences in elevation between the riprap swales and the storm drain inlets (Figure 1, Site Condition M, Photograph 12). The riprap swales should be regraded to proper elevation to allow proper drainage to enter the storm drain inlets. The PVMMD will contact the Solano Irrigation District to verify that they have responsibility for the surface storm drain improvements.

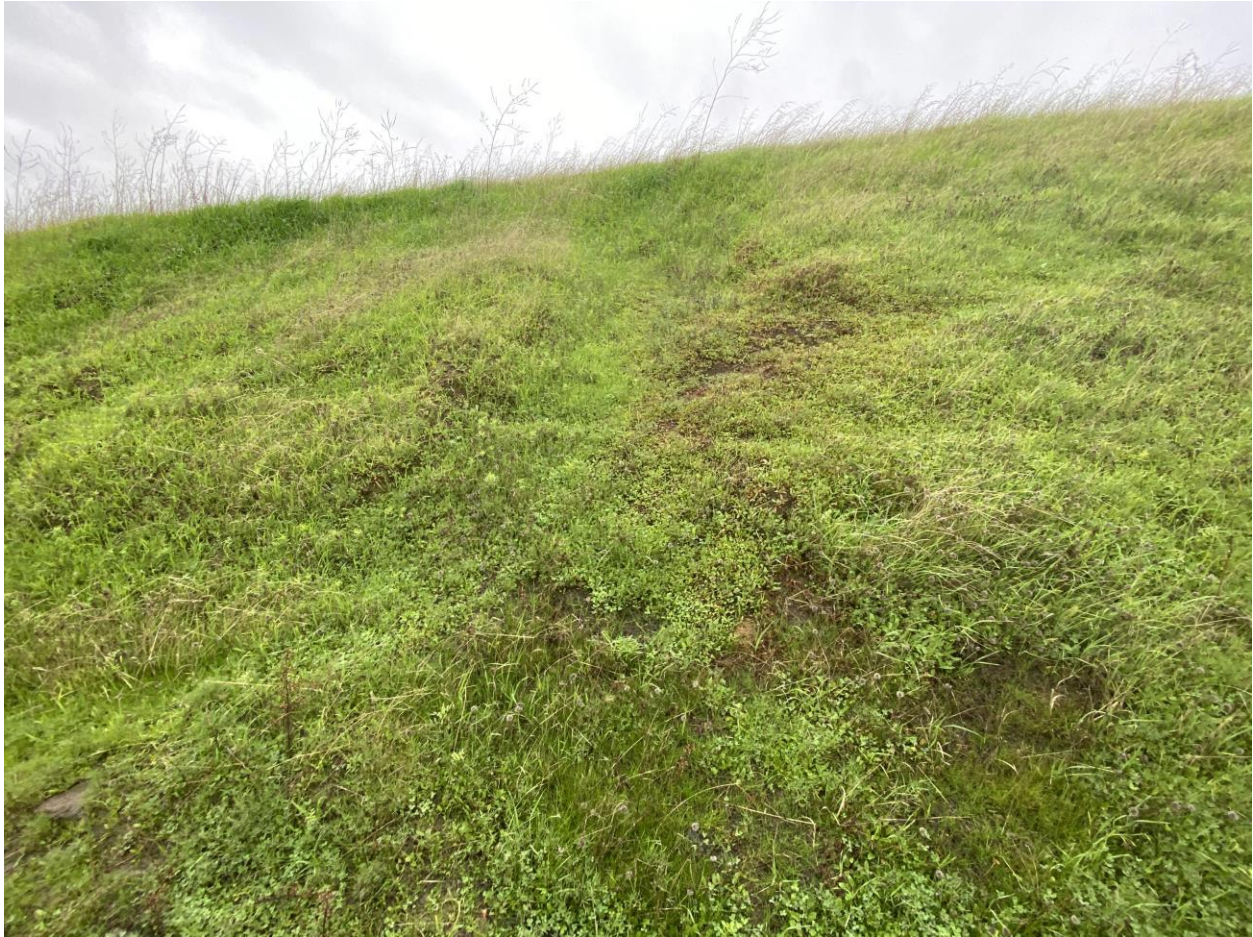
PHOTOGRAPH 13: Site Condition N

There are relatively shallow landslides along the embankments surrounding the Solano Irrigation Water Reservoir and along the paved access road to the reservoir (Figure 1, Site Condition N, Photographs 13 and 14). At the time of our site visit, the landslides were not affecting nearby improvements; however, they should be continue to be monitored.

Shallow landslide along embankment near Solano Irrigation District Water Reservoir

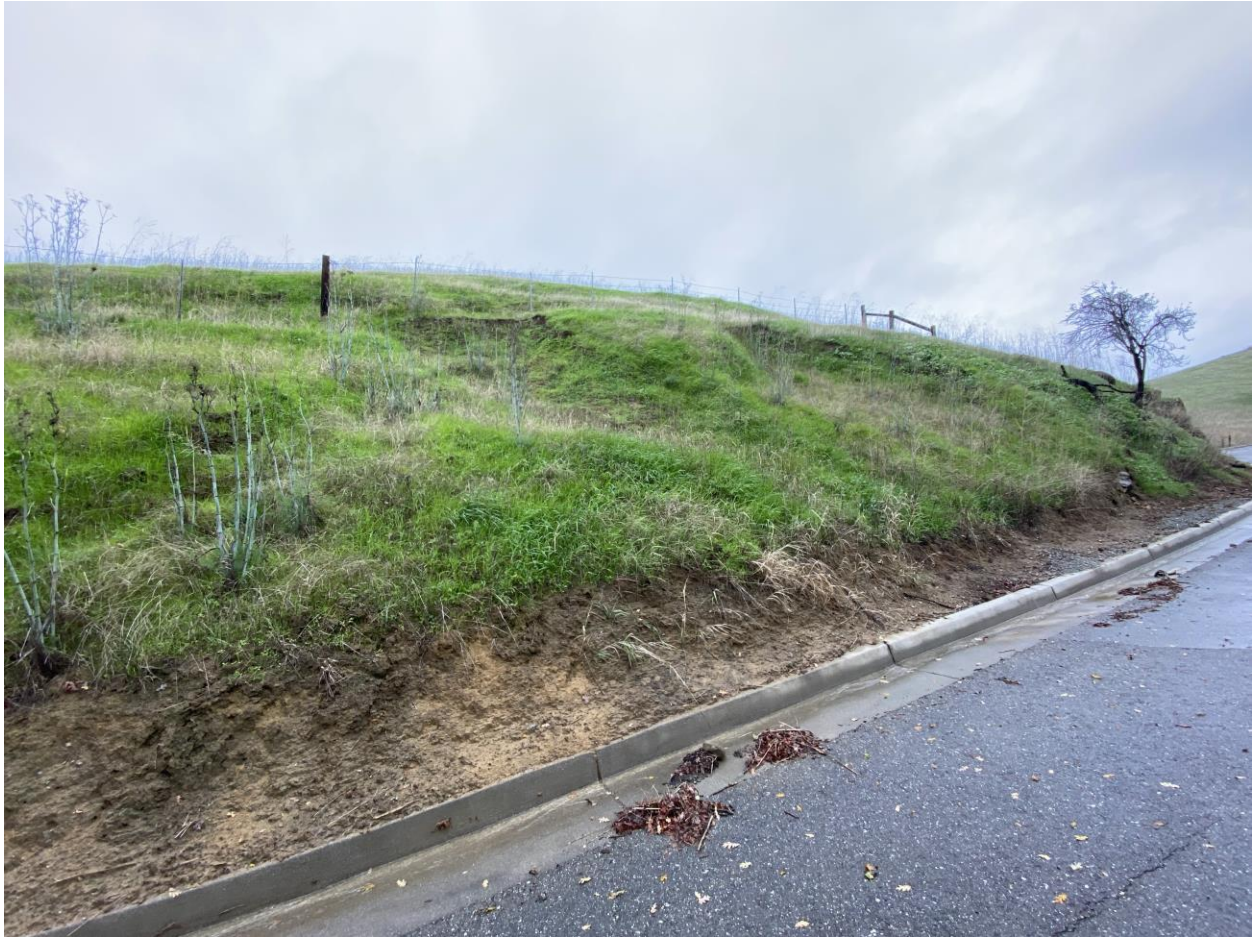
PHOTOGRAPH 14: Site Condition N

Shallow landslides along slope adjacent to paved access road to Solano Irrigation District Water Reservoir

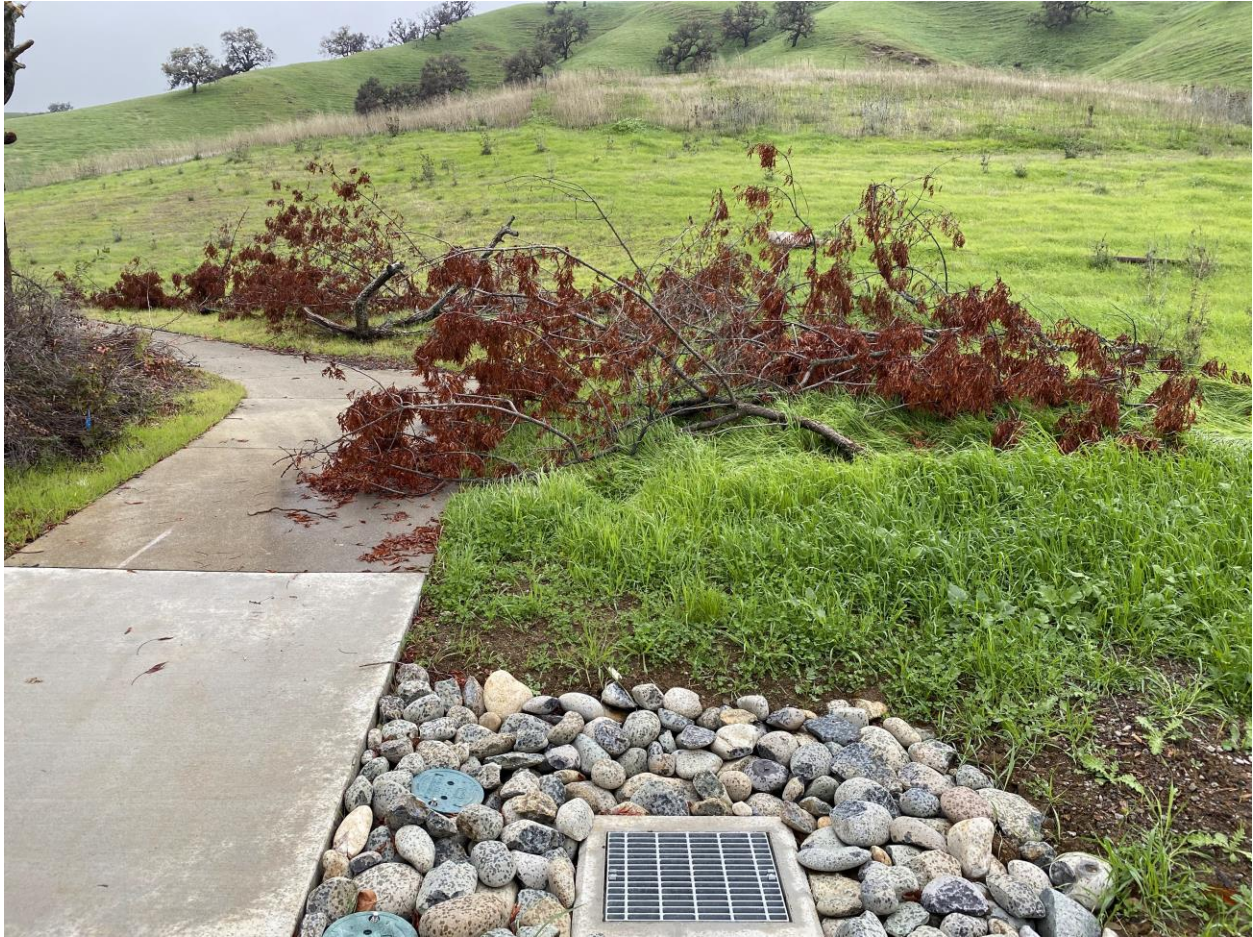
PHOTOGRAPH 15: Site Condition O

Vegetation deposited on PVMMD-owned open space north of Area "I"

In the open space north of Couples Court, there is cut vegetation and related debris within the PVMMD-owned and maintained open space (Figure 1, Site Condition O, Photograph 15). The vegetation and debris should be removed from the open space.
