Project No.
5698.002.021

Subject: Paradise Valley Maintenance and Monitoring District
Fairfield, California

MONITORING REPORT – FALL 2021

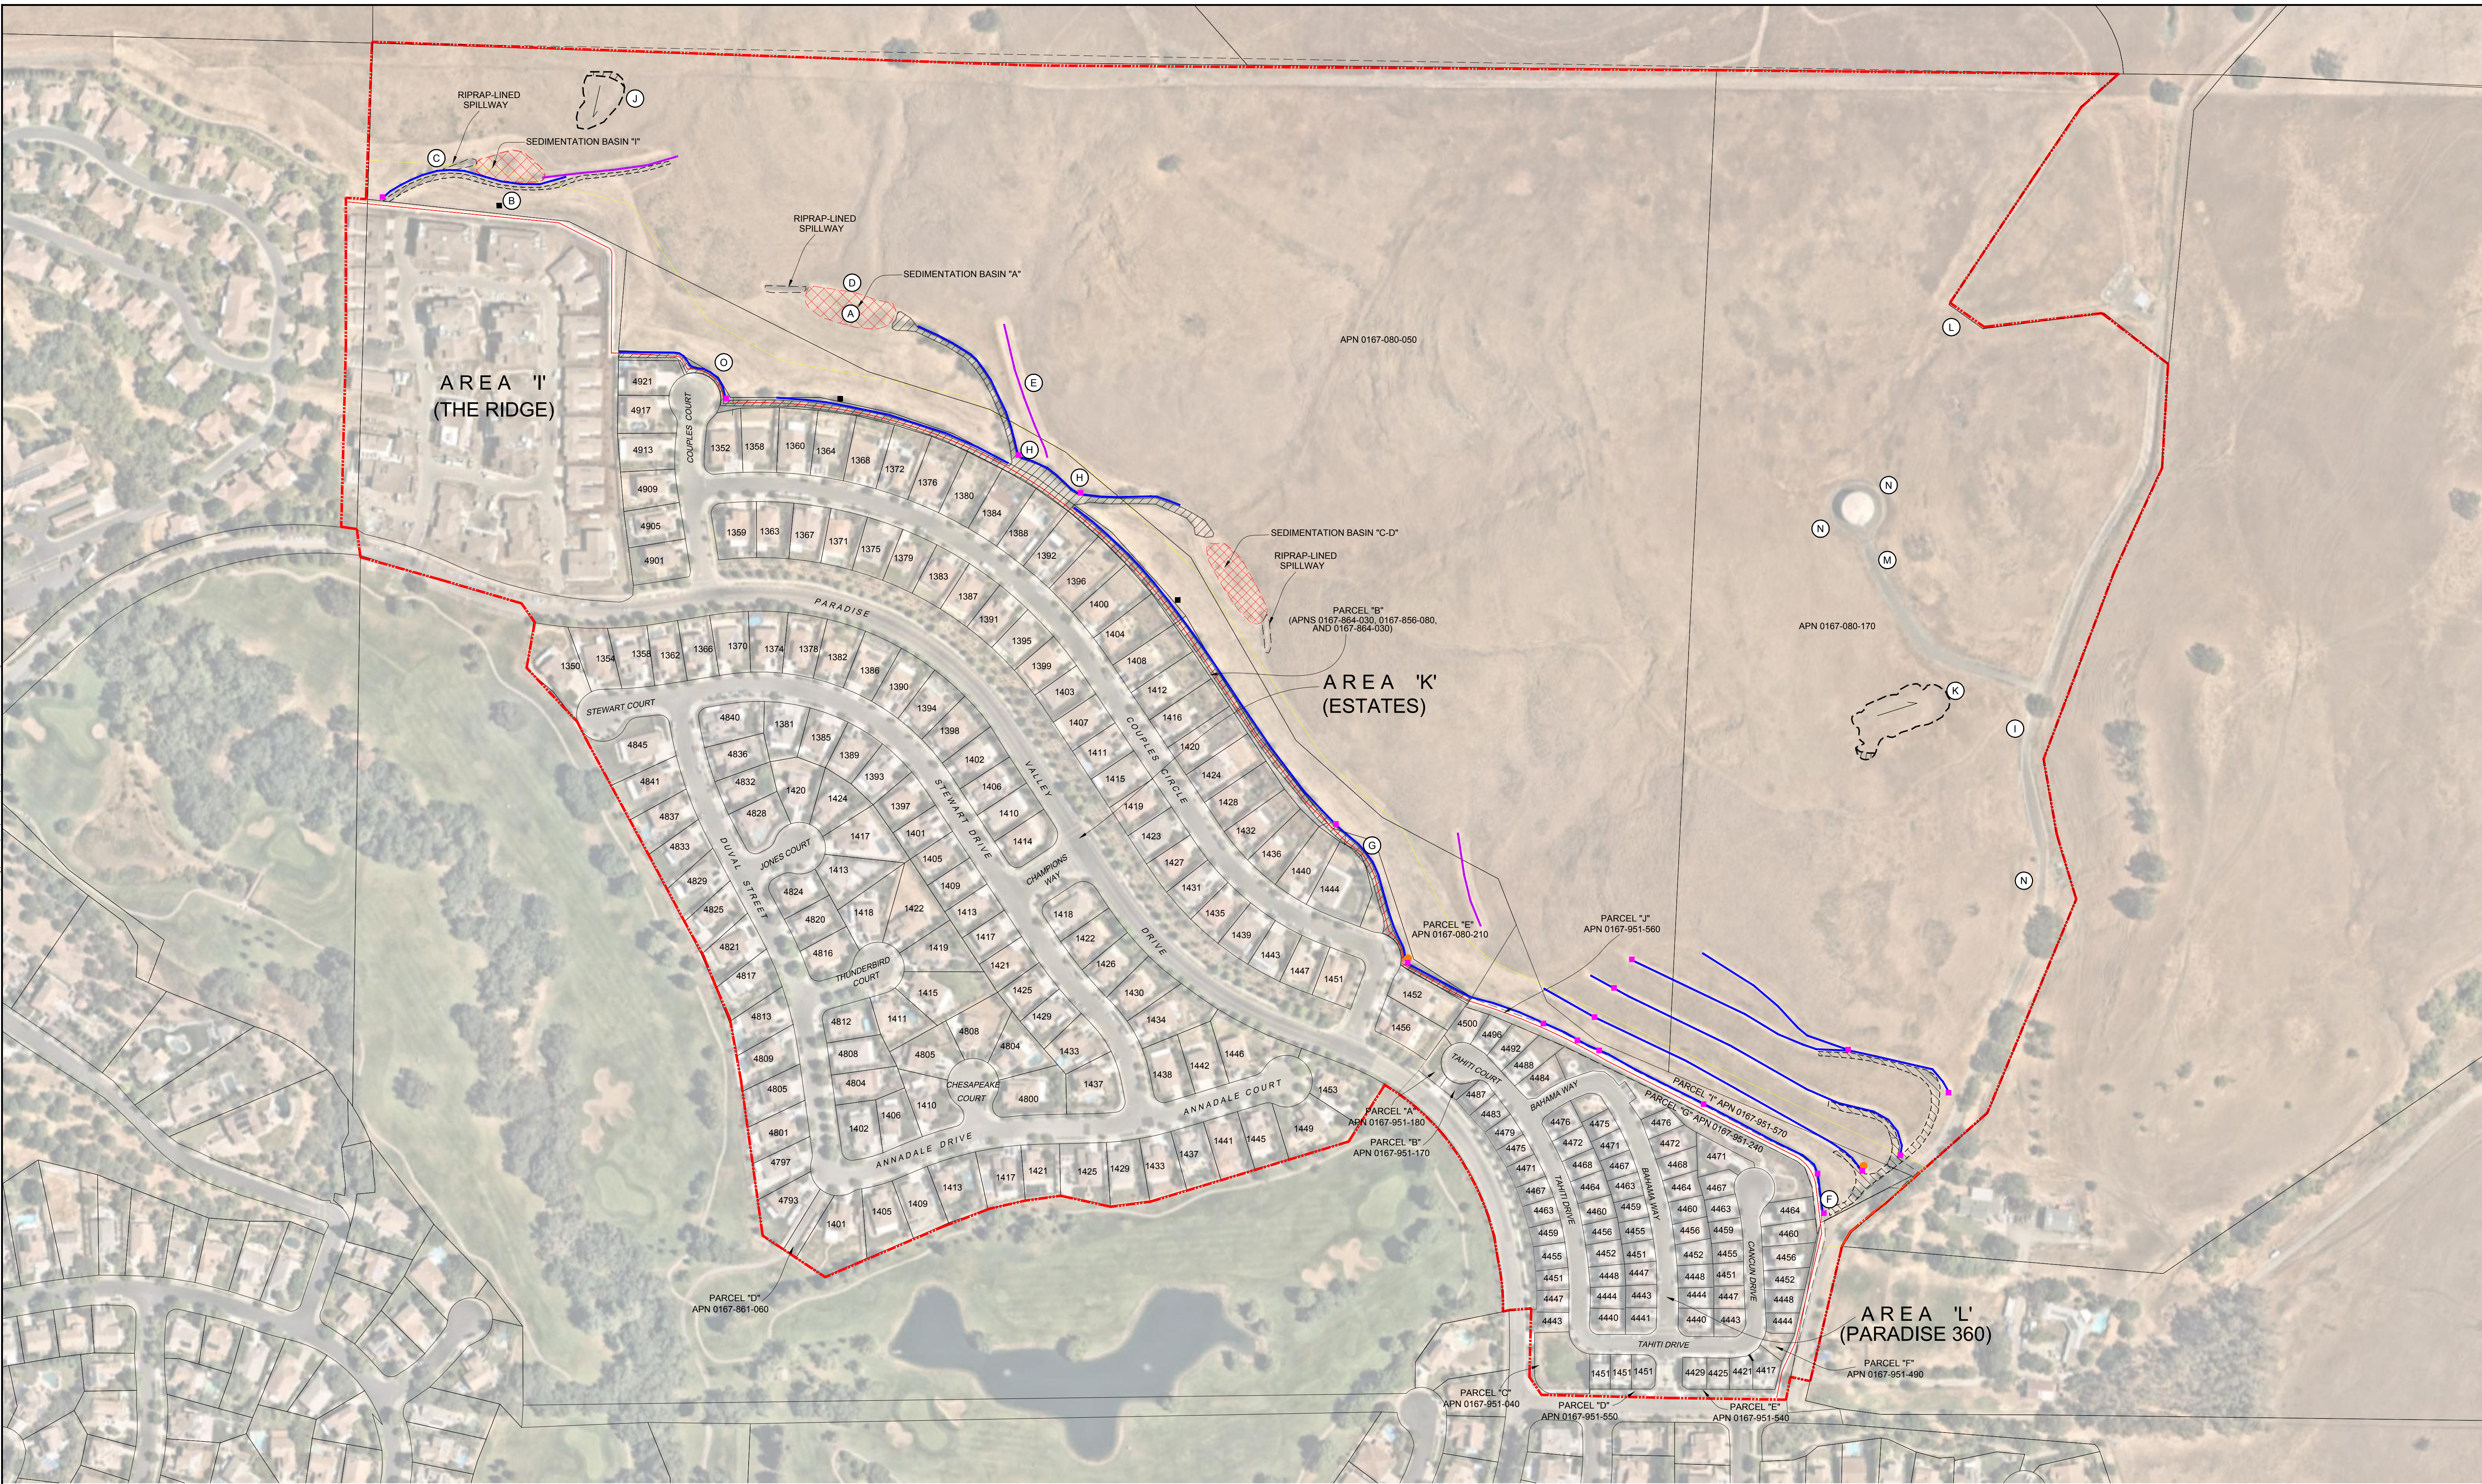
A landslide is located northeast of Sedimentation Basin “I” that measures approximately 110 feet in length and 75 feet in width (Figure 1, Site Condition J). It appears that this landslide reactivated during the winter of 2016/17. This landslide is not of immediate threat or concern to GHAD-maintained improvements, but should be monitored during future scheduled monitoring events as it could continue to move and deposit a significant amount of sediment to the sedimentation basin.

An erosion gully is located approximately 30 feet south of the access road to the Solano Irrigation Water District Reservoir (Figure 1, Site Condition K, Photograph 10). The gully is up to approximately 125 feet in length, 3 to 4 feet in width, and up to about 2 to 3 feet in depth. We recommend this erosion gully be backfilled with riprap as described in Reference 5.

Additionally, there is an erosion gully near the offsite underground water storage facility that drains into the offsite concrete-lined drainage ditch (Figure 1, Site Condition L, Photograph 11). At the time of the site visit, these erosion gullies do not threaten any improvements within the open space, but should be monitored during future scheduled monitoring events.

There are two riprap swales with storm drain inlets along the Solano Irrigation District Water Reservoir paved access road. Significant erosion gullies are present within the riprap swales due to the differences in elevation between the riprap swales and the storm drain inlets (Figure 1, Site Condition M, Photograph 12). The riprap swales should be regraded to proper elevation to allow proper drainage to enter the storm drain inlets. The PVMMD will contact the Solano Irrigation District to verify that they have responsibility for the surface storm drain improvements.

There are relatively shallow landslides along the embankments surrounding the Solano Irrigation Water Reservoir and along the paved access road to the reservoir (Figure 1, Site Condition N, Photographs 13 and 14). At the time of our site visit, the landslides were not affecting nearby improvements; however, they should be continue to be monitored.

In the open space north of Couples Court, there is cut vegetation and related debris within the PVMMD-owned and maintained open space (Figure 1, Site Condition O, Photograph 15). The vegetation and debris should be removed from the open space.
